This report is in regards to the incident regarding the blow up rifle, Colt sn# A0225253 with the LWRCI 10.5 inch upper receiver. My conclusion is that the incident was ammunition related.

Christopher Bartocci
Small Arms Solutions, LLC

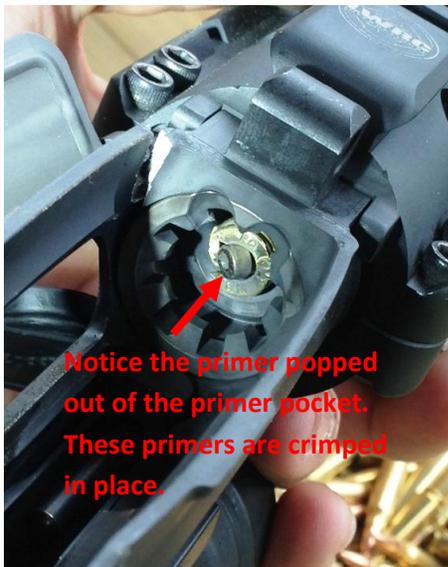
Notice the bulge in the cartridge case caused by the rear of the cartridge case not being supported by the chamber. The bolt was unlocked at or near the peak of the pressure curve.

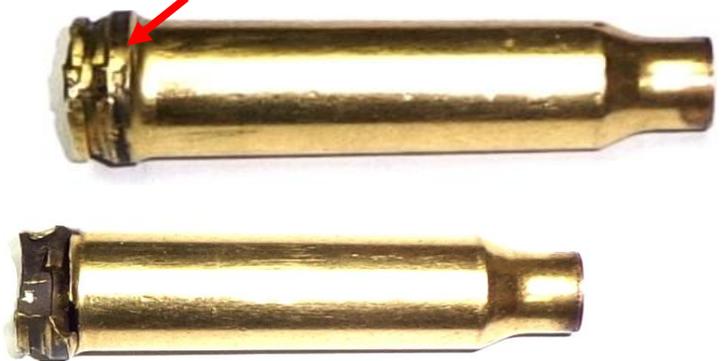
The failure of the cartridge case was the portion engaged by the extractor.

Examination of the cartridge case that was removed from the chambered showed signs of bulging just above the rim showing where the cartridge case was unsupported by the chamber. The primer was blown out. The portion of the cartridge case that failed was right where the extractor grabbed the rim. See photographs on page 1 for details.

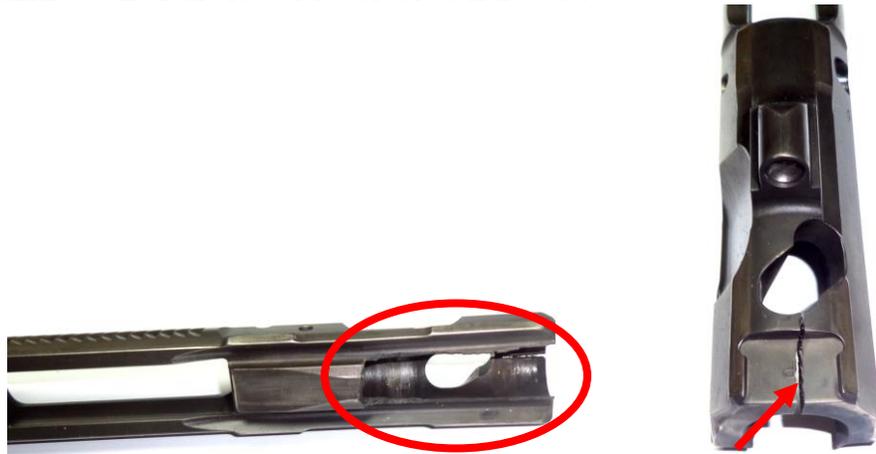
When the cartridge was fired, the pressure well exceeded the normal 55,000 psi, perhaps even doubled. This caused the port pressure to be so high that the operating rod struck the bolt carrier and began the unlocking process prior to the pressures dropping in the chamber. At this point the cartridge case slightly moved to the rear, causing the rear to be unsupported in the chamber with the pressures still extremely high. The cartridge case base ruptured causing the bolt face to crack, extractor to bend, bolt carrier top to crack right through to the cam track, cause the bottom of the carrier achieve structural failure and the magazine well of the lower receiver to flare out.

Notice the large portion of material missing from the bottom of the bolt carrier as well as the crack in the top, front of the bolt carrier right thorough the cam track.

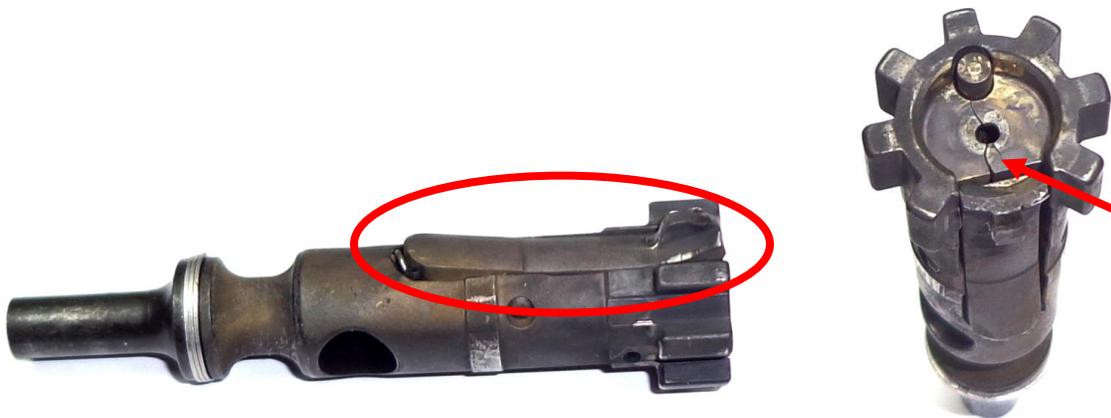
Notice how the extractor is bent and the extractor spring and buffer are sticking out of the rear of the extractor. Observe the cracked breechface of the bolt.

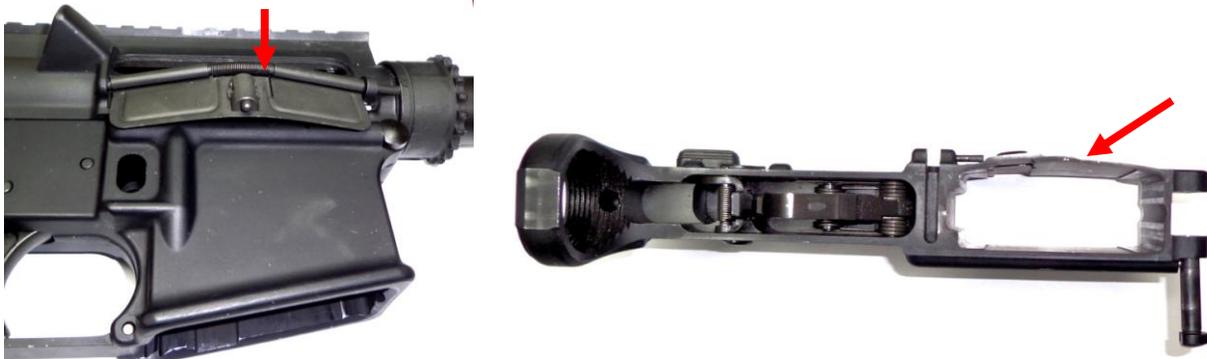
The ejection port area of the receiver was pushed out as well as the ejection port cover and ejection port cover rod are bent. The magazine well of the lower receiver bulged out on the left side due to the over pressure gas escaping through the magazine well.

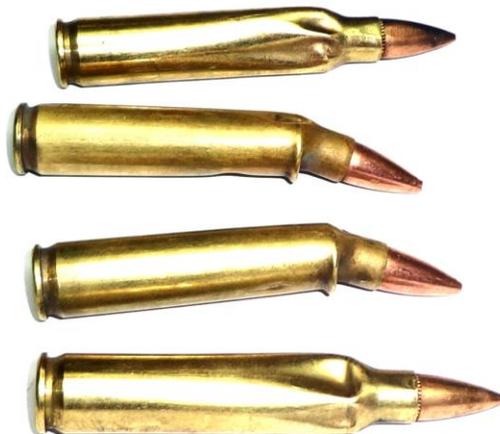
Other unfired cartridges were submitted for examination. These came from many different rifles on the line this day using the stated ammunition. These were all failures to feed from the magazine into the chamber. Some of these showed the projectile portion of the cartridge bent upward. Others showed straight dents/scrapes on the body of the cartridge case. These were caused by overgassing the operating system. The velocity of the bolt carrier was so fast that the magazine spring could not raise the shot column in time for the bolt lugs to catch the rim to feed the cartridge into the chamber. Instead, the bolt over rode the rim and as the shot column in the magazine rose up, the lug of the bolt caught the front of the case in the body behind the shoulder. The lug dug into the brass moving the

cartridge case slightly forward up onto the feed ramps when the bolt carrier group slammed into the top of the cartridge and bent projectile on the same angle as the feed ramp.

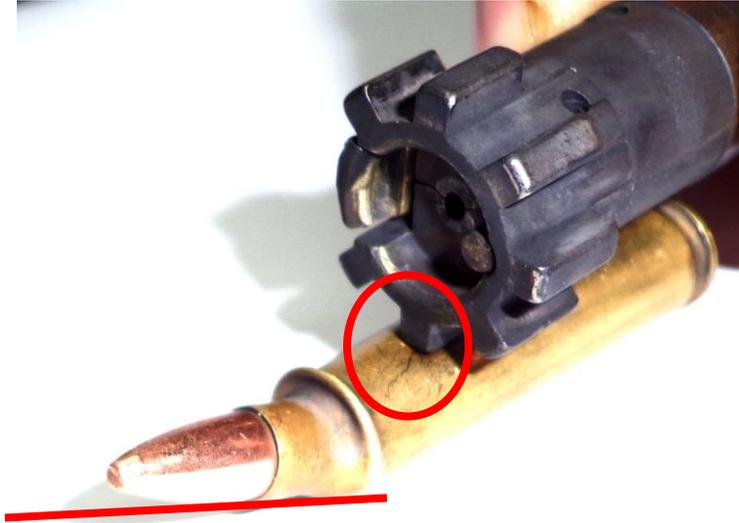
Notice how the lug of the bolt dug into the forward portion of the cartridge to the back side not being in the feeding position because the magazine spring could not lift the shot column fast enough for the lug to engage the rim to push the round into the chamber. Pushes the nose of the cartridge case partially into the feet ramps/barrel extension when the bolt carrier group fully moves forward bending the tip of the cartridge on the feed ramp.

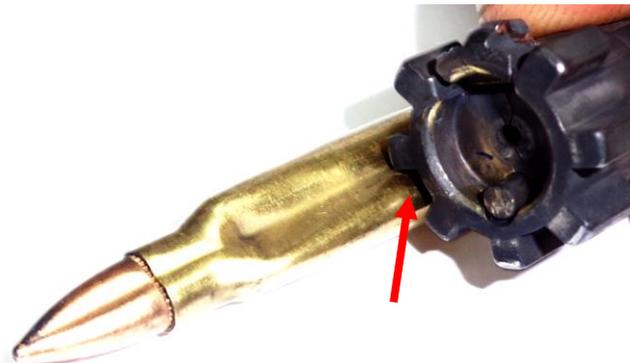
This cartridge did not move up in the magazine by the time the bolt lug met the rim. As the bolt over rode the rim the column rose enough to engage the bolt and dig into the body of the cartridge. This round remained in the magazine. This too is due to excessive cyclic rate.

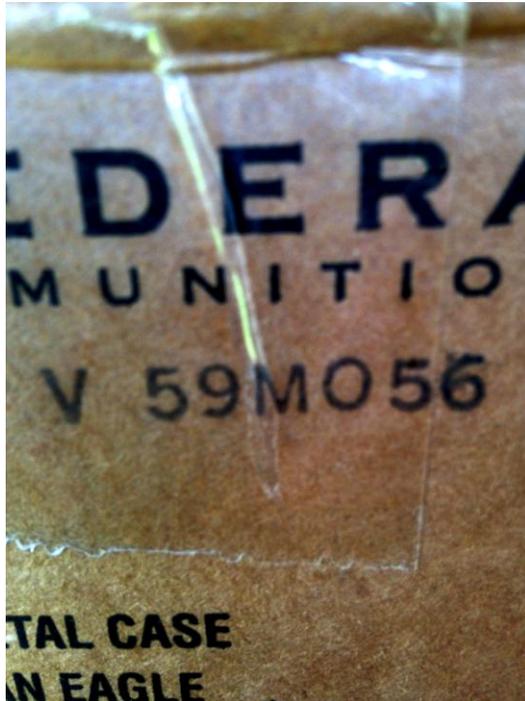
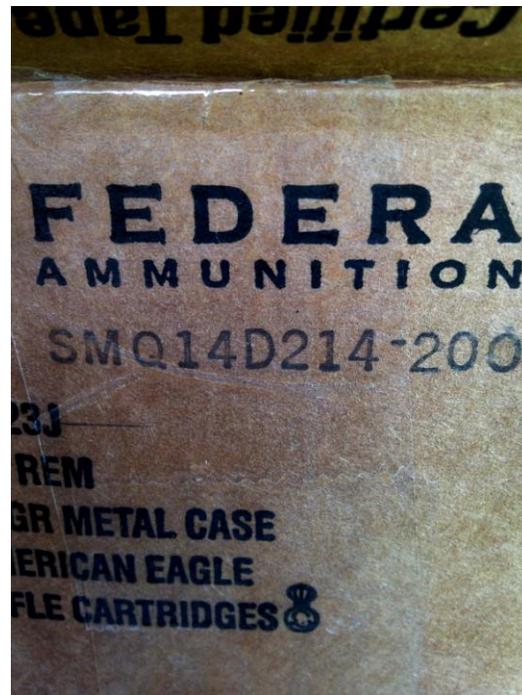
There were two lots of ammunition used that day. As of this moment it has not been determined which lot of ammunition has caused these failures. Below are photographs of the lot numbers (V59M056 and SMQ14D214-200) located on both of the boxes the ammunition was received in:

Both cases of ammunition are Federal, American Eagle (AE223J), 223 Remington caliber, 55 grain full metal jacket. Majority of the failures had nickel primers with blue primer sealant with a headstamp reading FC 14 223 REM. There were three with brass color primers with a head stamp .FC.223.REM. and all cartridges have staked primers. The round that caused the failure in the rifle was the nickel primer with headstamp FC 14 223 REM.
